Technical Specification Bulletin Number 222

Oil Control Knob Replacement

Oil Control Knob Replacement for 38536

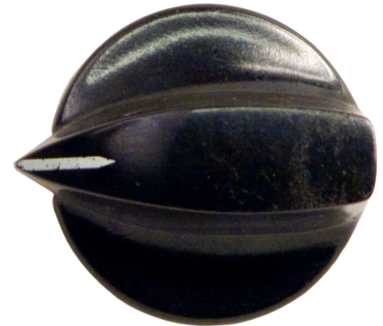
The plastic oil control knob (38536) which has a small retaining grub screw has been discontinued by the manufacturer and a replacement has to be used in its place (MS2322). The surrounding bezel remains in place on the stove.

Discontinued Control Knob

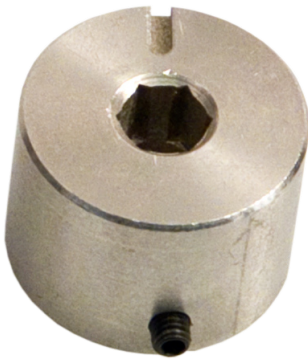
In place of the original is a metal control knob which comes complete with a grub screw and small allen key.

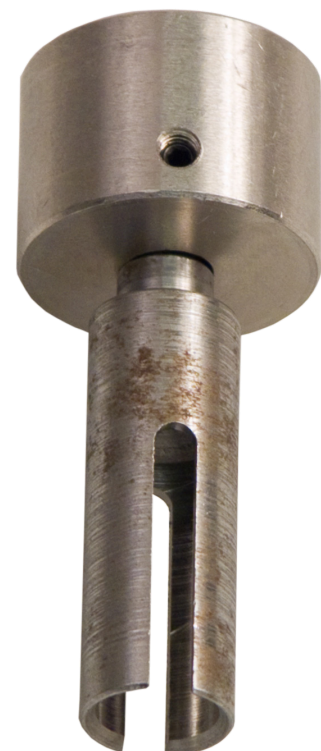
← Dimple into which the grub screw must locate

The control knob should be slid over the shaft and the grub screw aligned with the dimple on the shaft so that when tight the control knob will not slip on the shaft.
