Maintenance & Servicing Instructions

Harmony 13,23,33,43

Stanford 13,23,33

Wood & Multifuel Stoves
IN1195 Edition D July 2016

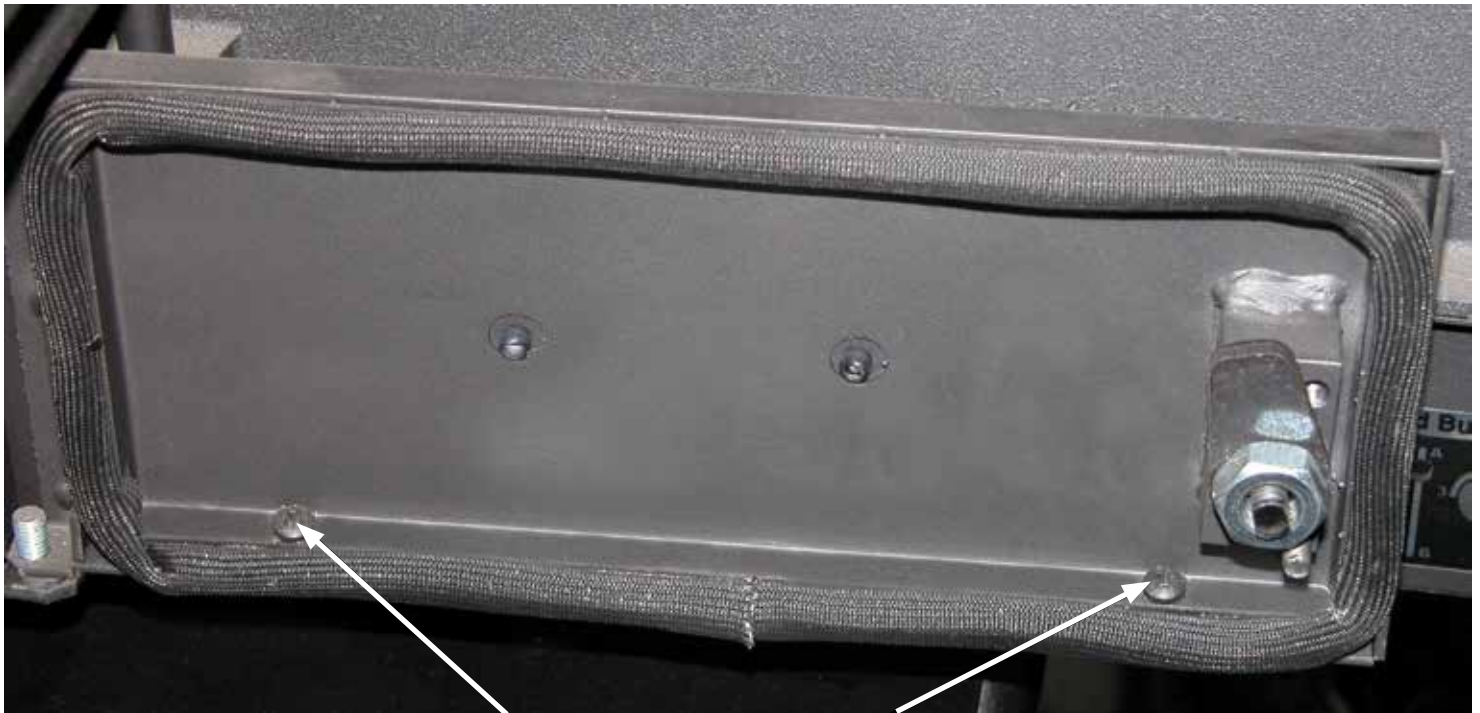
If there are any self tapping screws holding the hollow rope seal in place remove these. Pull the old rope seal from the rope groove, it may require a flat bladed screw driver to lift it from the groove. Clean the groove of all accumulated dirt and old rope glue, a flat bladed screw driver and wire brush are recommended to clean the groove.

**Self Tapping
Retaining Screws**

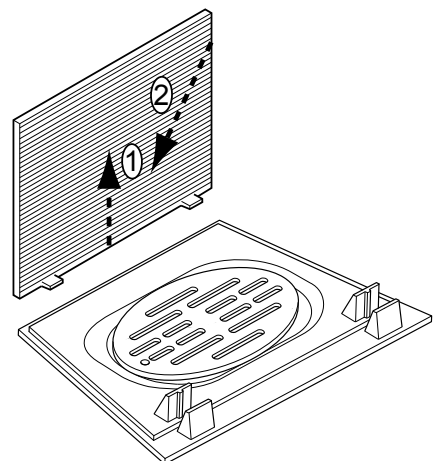
Removal of the Side Protection Plate H23, S23 & SP23

To remove (1) lift up the plate so it is higher than the grate frame and then (2) twist the rear edge towards the front of the fire box. It can then be angled within the fire box to withdraw it through the door.

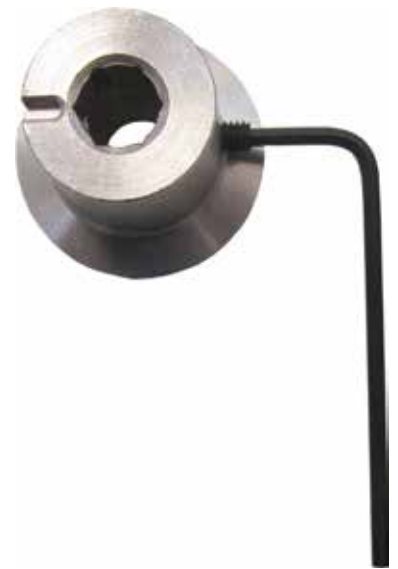
The air volume control knob has a small grub screw (FF4029) which fixes it onto a rod which operates the air control, plexus unit. If the grub screw works loose over time then it will need to be tightened back up using the small allen key that is supplied with the stove. Ensure that the grub screw is tightening down onto the flat surface on the rod.

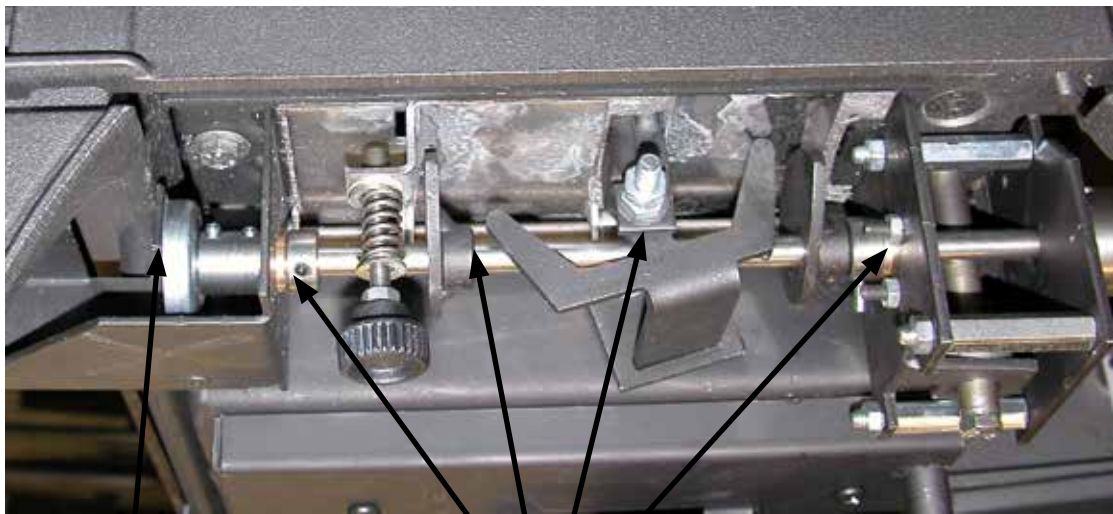
The unit itself needs very little maintenance other than a small amount of lubrication if the controls become stiff. A light oil, such as WD40, is all that is required and can be applied whilst the plexus unit is fitted to the stoves body. The picture below shows the points at which the oil should be to be applied.

Point where a small amount copper grease can be applied.

Points where a small amount of a light oil can be applied.

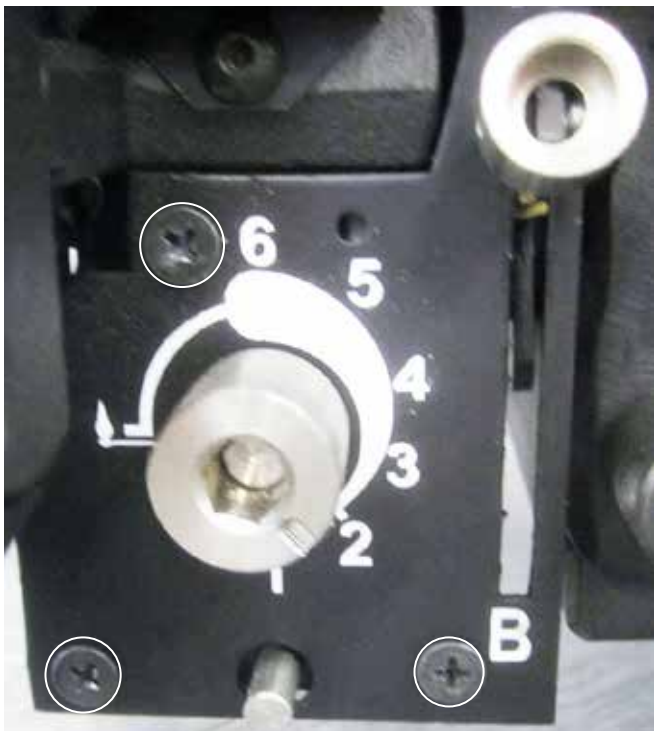
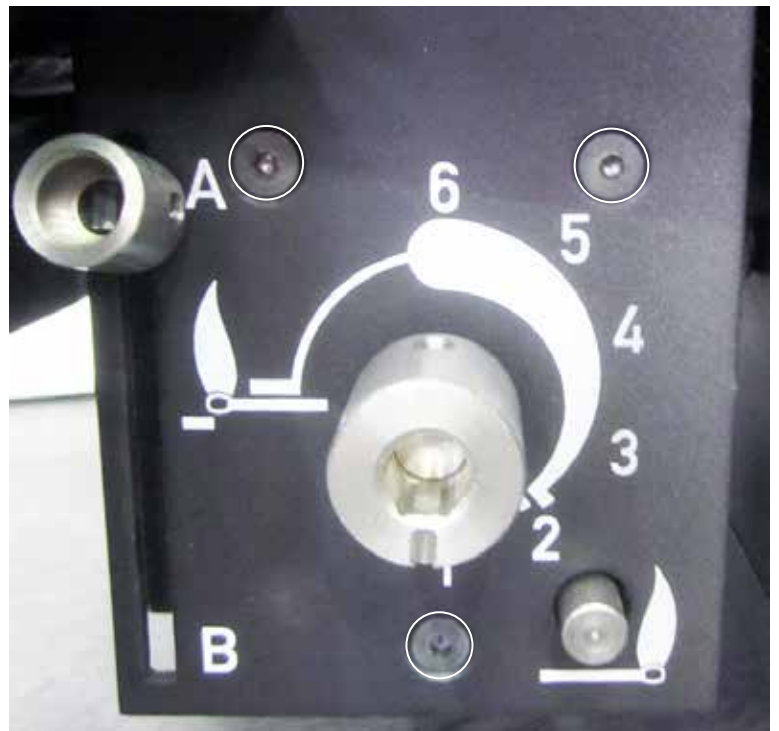
4) Remove the Front Fixing Bolt

There is a fixing bolt at the front of the plexus which holds the unit against the base of the stove, see pictures below. This needs to be removed.

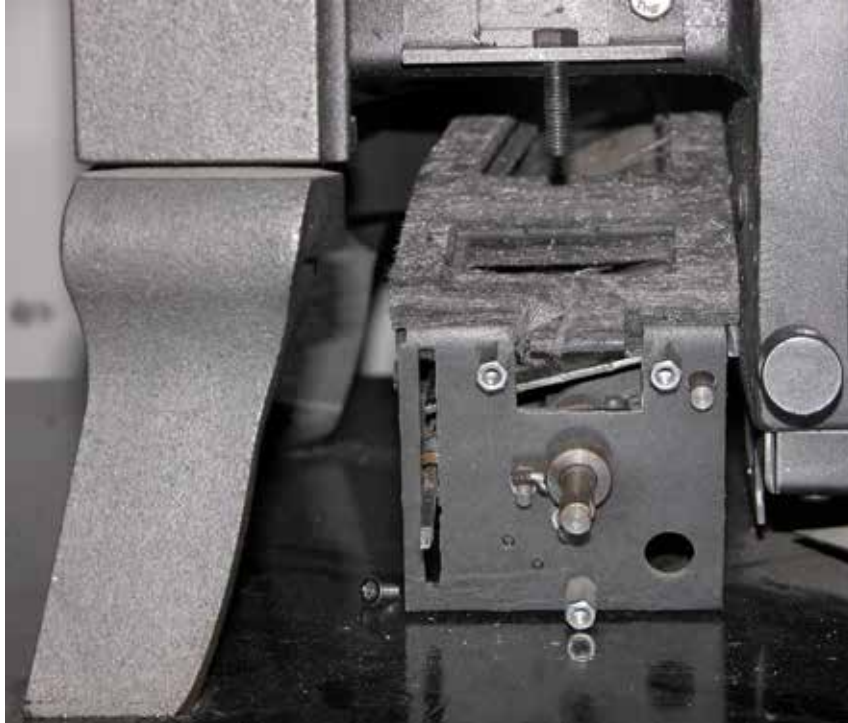
5) Drop the Front of the Plexus Down

Once the bolt has been removed the front of the plexus unit can then be lowered down and slid forward to remove it from the body of the stove.
