Baffle and Gasket Fitting

Firebox Components - Montfort Elegance

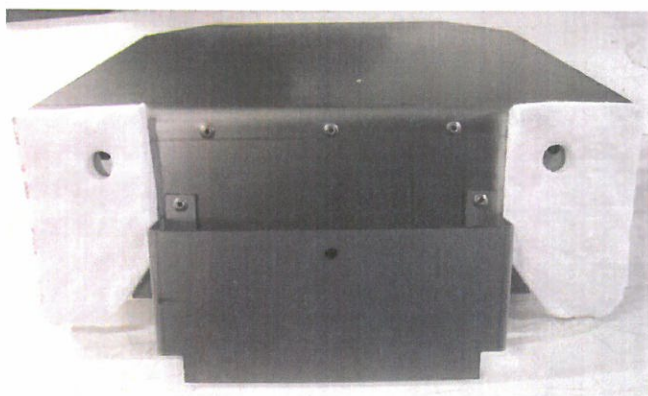
It is best to stick the gaskets to the top of the baffle plate, as shown below with the holes in the gasket corresponding to the holes in the top of the baffle, so that when the baffle is pushed up they do not move and obstruct the air holes in the air ducts to the tertiary air box.

- 6) We recommend that the inside of the stove should be vacuumed clear of ash when this procedure is done and also at the end of the heating season.
- 7) Ensure when refitting the baffle that new gaskets FB142908 are used to ensure that the air does not leak in above the baffle where combustion could occur damaging the baffle, see page 14.
